# GULLY MITIGATION FIELD GUIDE

CAPE YORK  
MAY 2018

## INTRODUCTION TO THE CROCODILE GAP GULLY REMEDIATION SITE

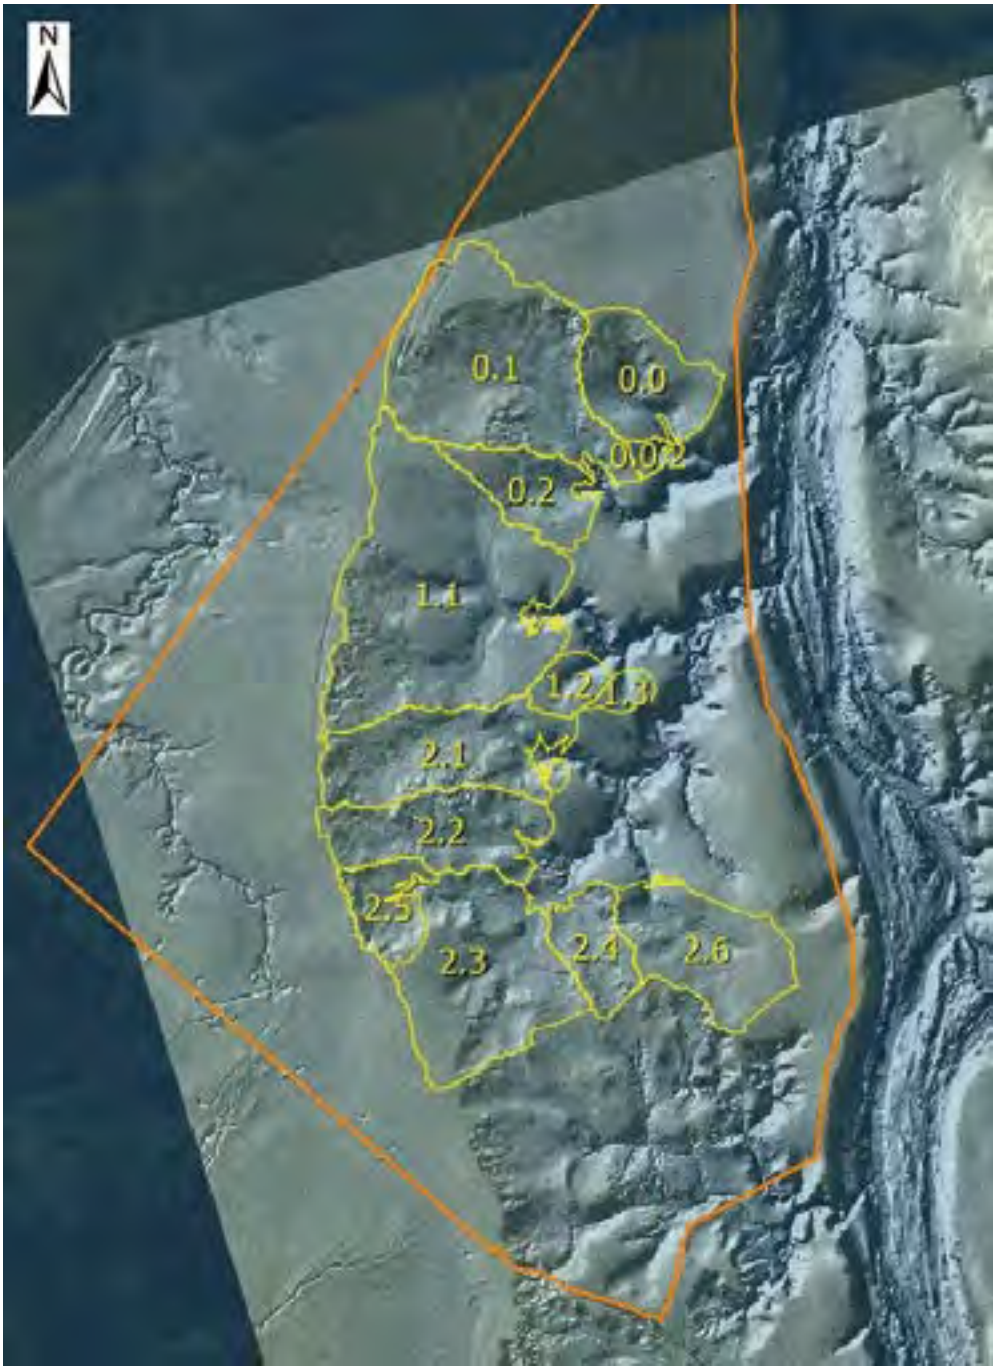
Figure 1. Physiography of the Crocodile Gap study area, using a DEM from 2009 1 m LiDAR and satellite imagery, as a basis of the geomorphic and soil materials description in this section. Includes the outlines and IDs of the gully catchments under investigation (yellow) and boundary enclosure fence (orange). Laura River is on the right. Earls Creek is at bottom right. The pale outline is the approximate boundary to figures 2 and 5. (R. Thwaites)

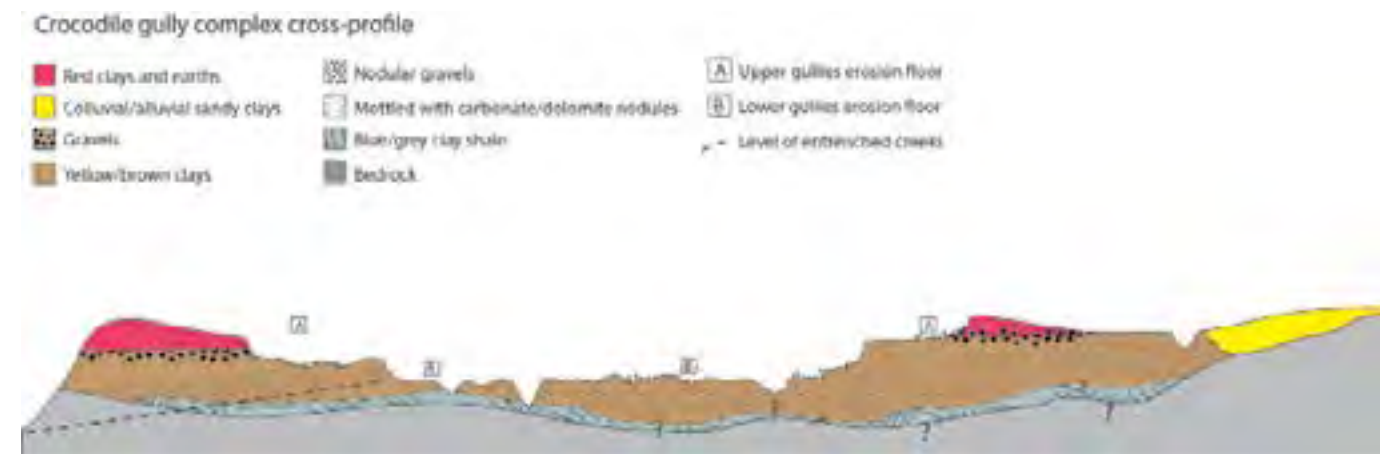
Figure 3. Schematic conceptualised cross-section of the main gully zone in the study area from east to west from The Laura River to the slopes of the Byerstown Range. (R.Thwaites)

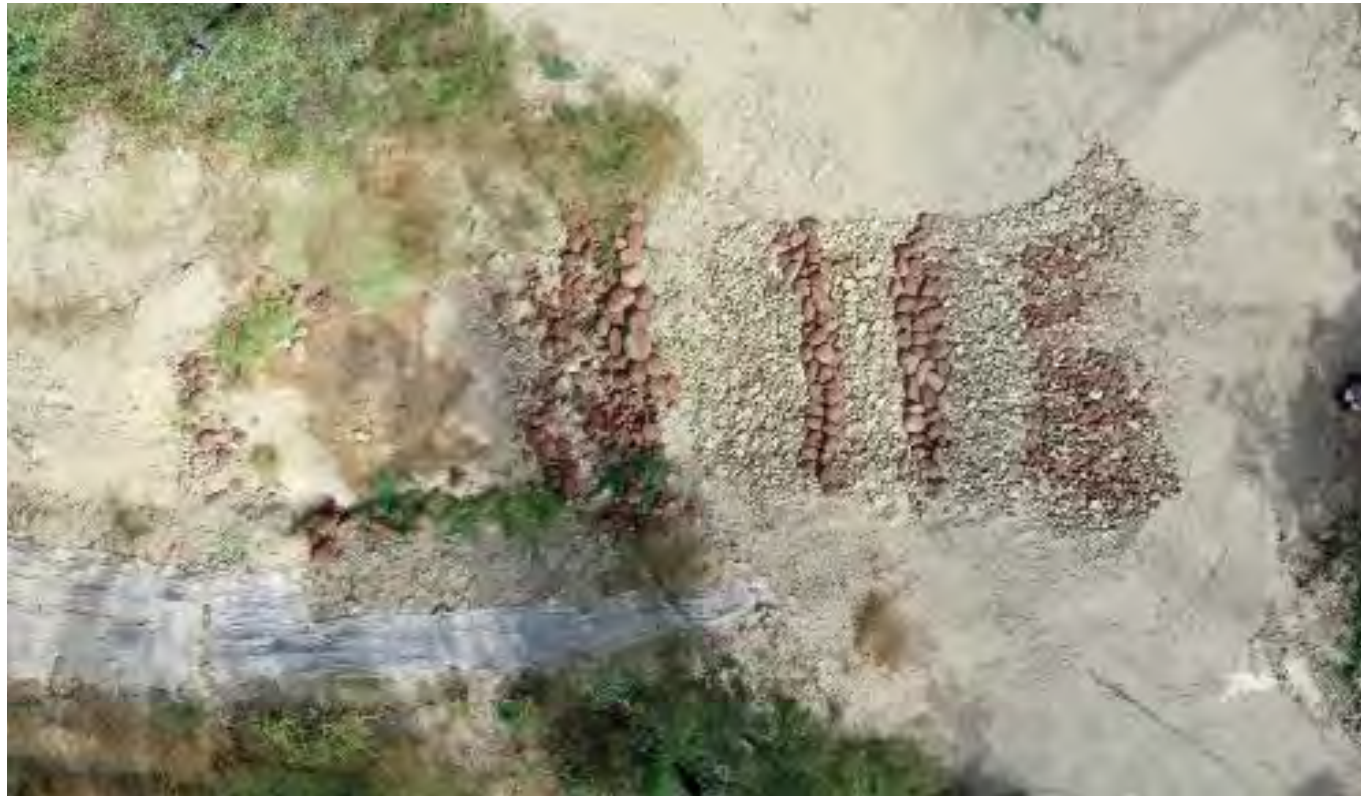
Gully 0.1 Aerial view of engineered rock chute

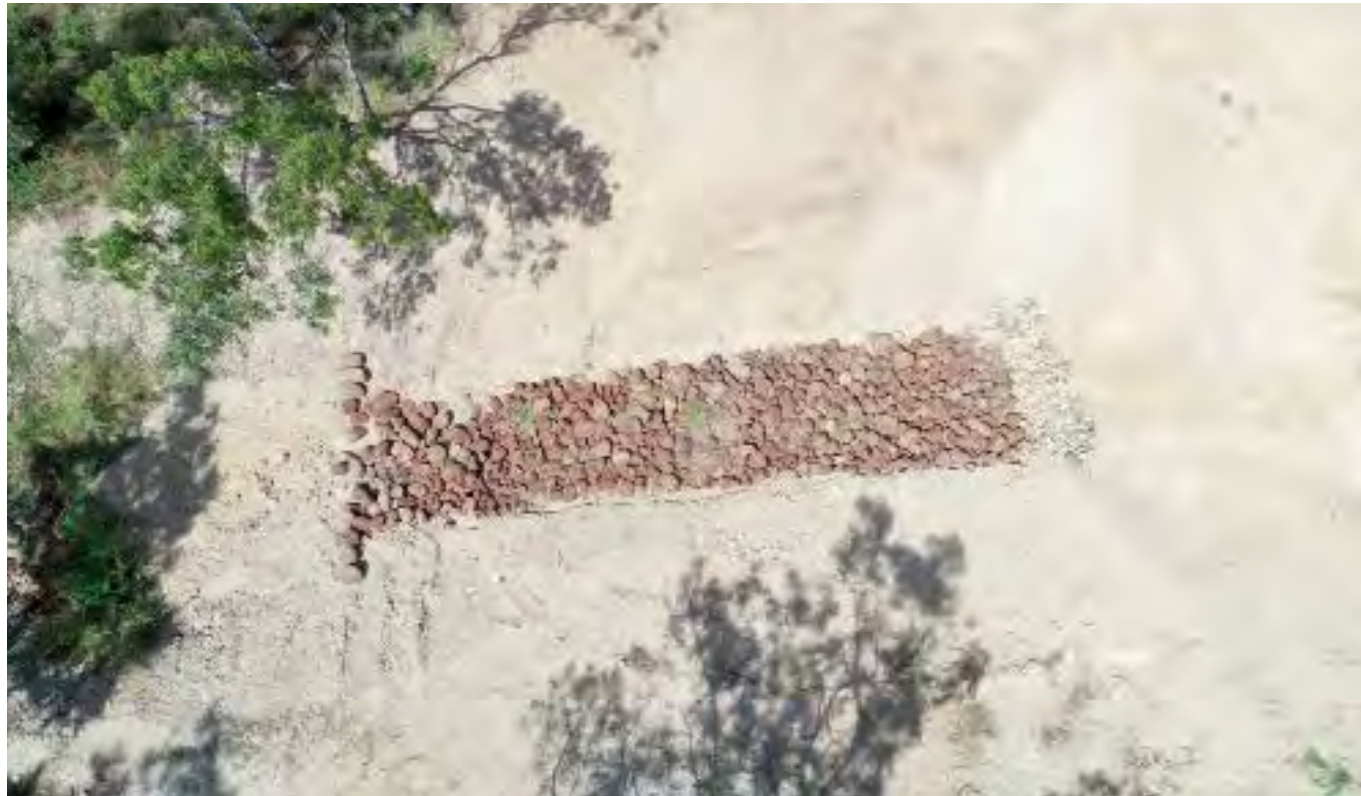
Gully 0.2 aerial view of engineered rock chute

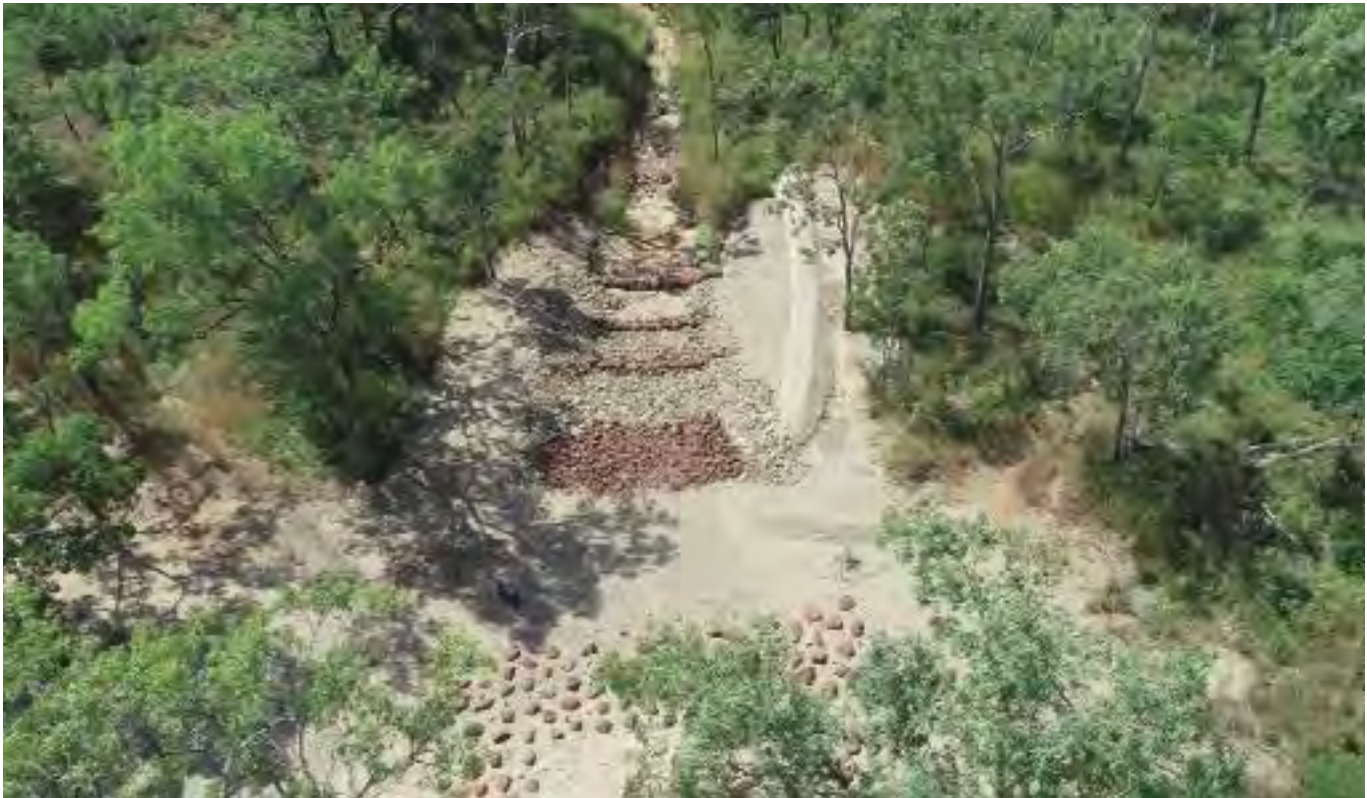
Gully 1.1 aerial view of engineered rock chute

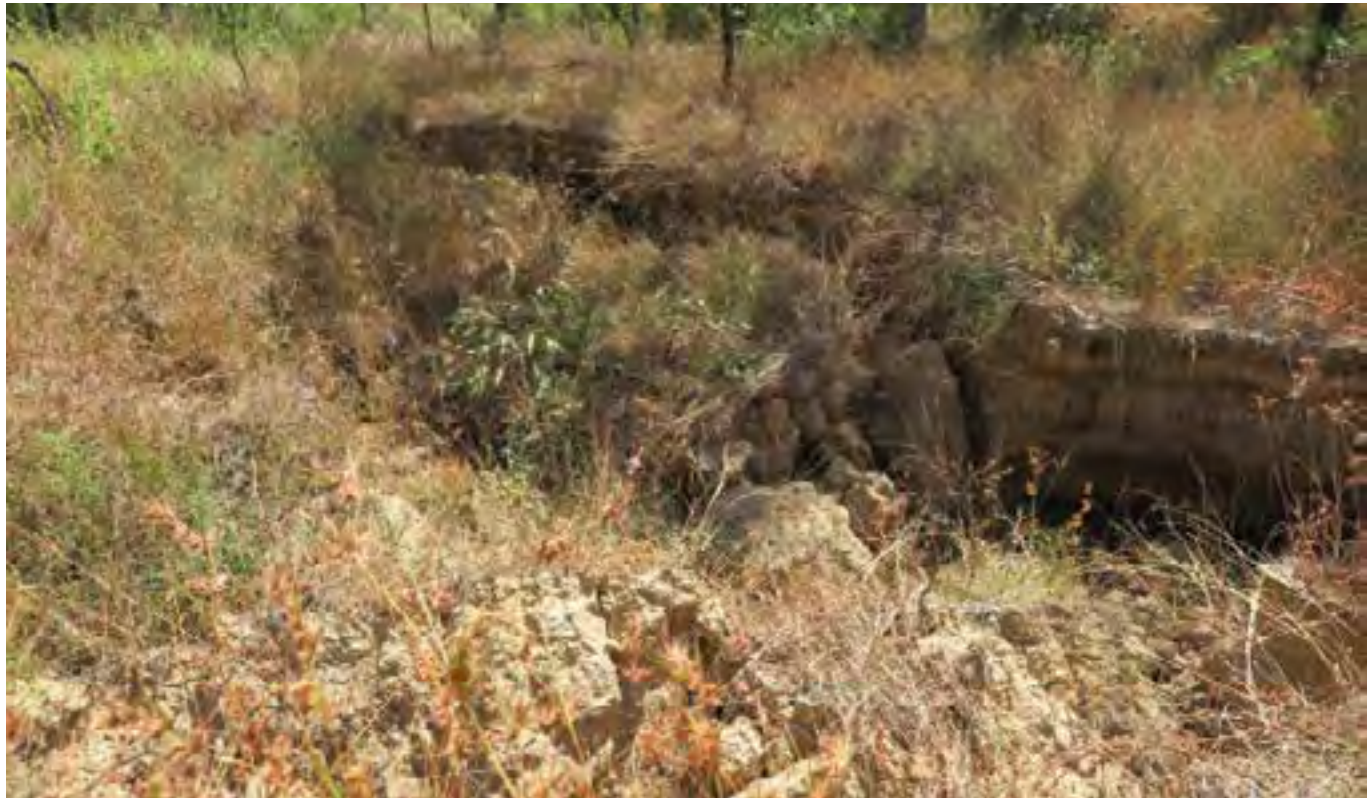
Slumping above Gully 2.1 due to tunnelling during the 2017-18 wet season

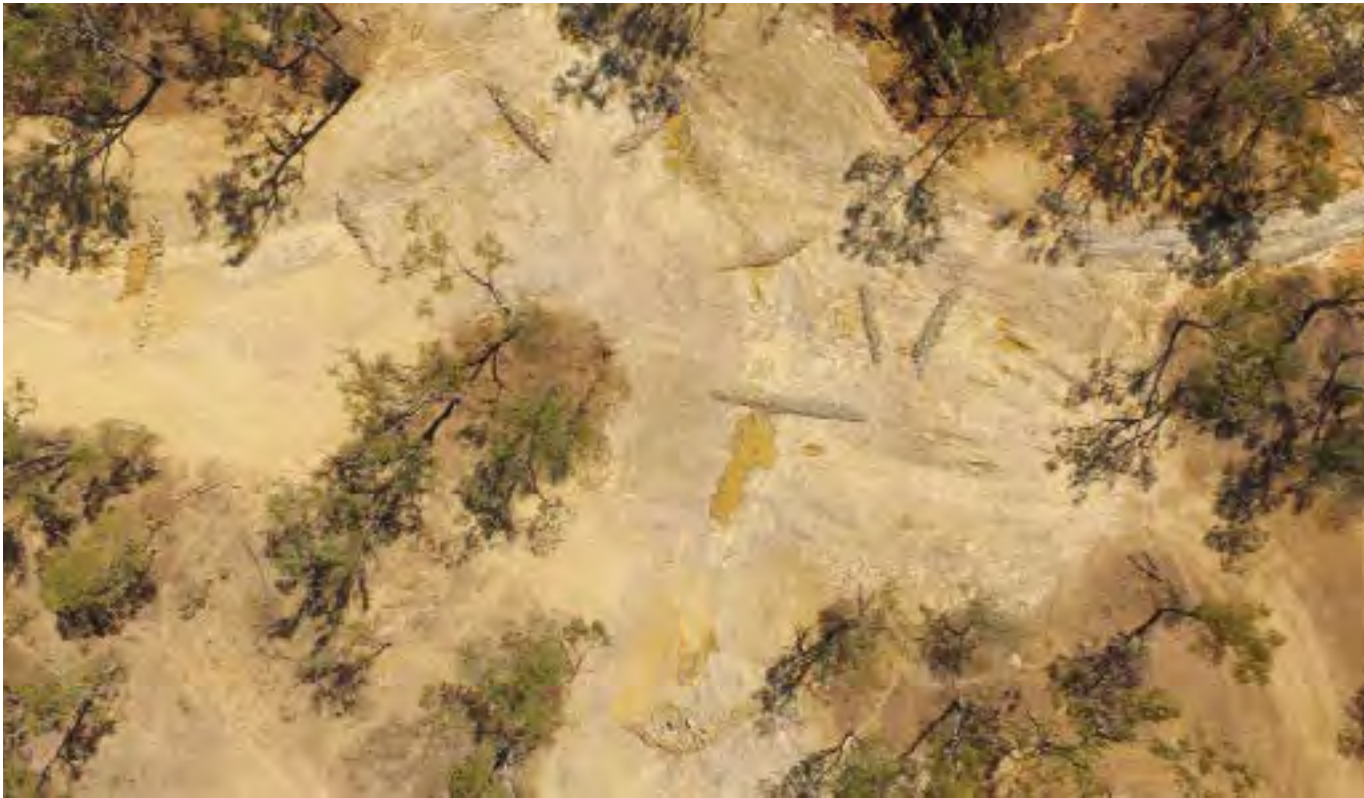
Gully 2.2 - 2.4 aerial view of engineered gully

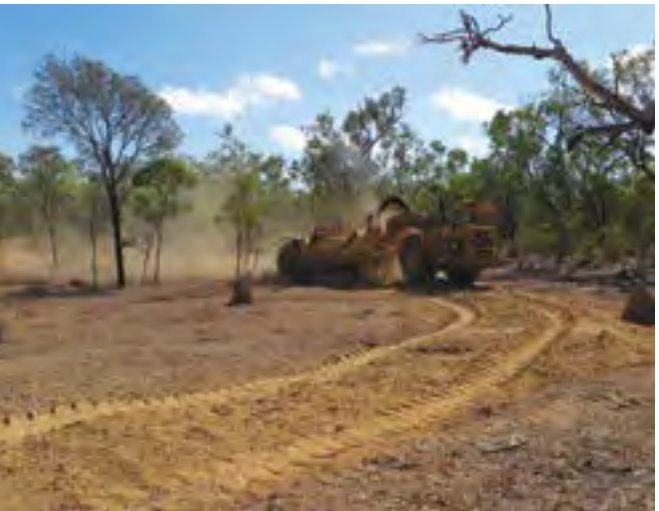
Laying of material for contours

As a means to utilise the highly dispersive soils from gullies 2.2 - 2.4 we constructed contour banks. The banks acted as a means to slow and distribute the flow of water from the sub-catchments.

The dispersive soil was capped with a rock lining to prevent erosion.

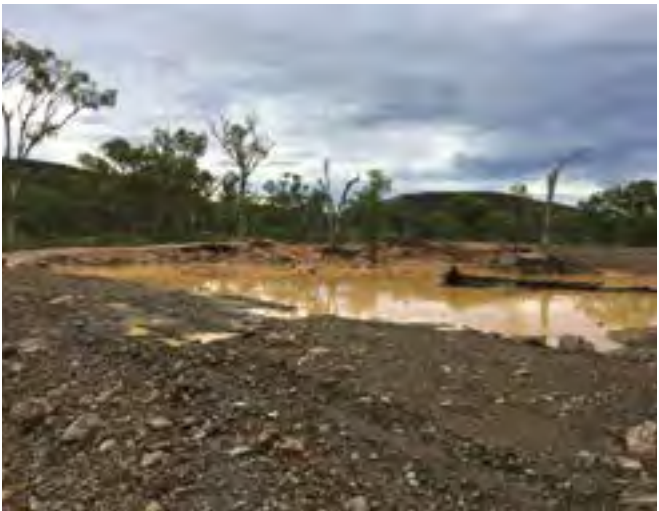
Contour bank

The contour banks have created small wetlands that have become feeding grounds for numerous species of wetland birds.

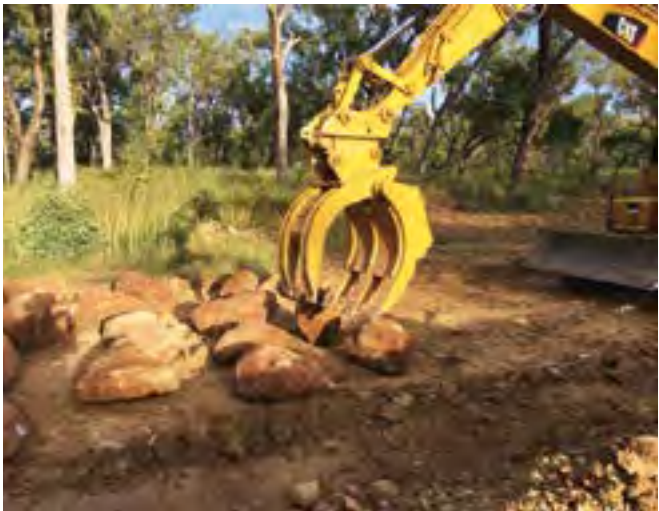
Placement of rocks

The flow constrictor was built to create an obstruction in the convergence area of the two sub-catchments (one 9.5-hectare and one 2-hectare). The difference in water flow volume between these two sub-catchments had previously caused uneven pressure on the rock chute. With the flow constrictor in place, water is now distributed evenly.

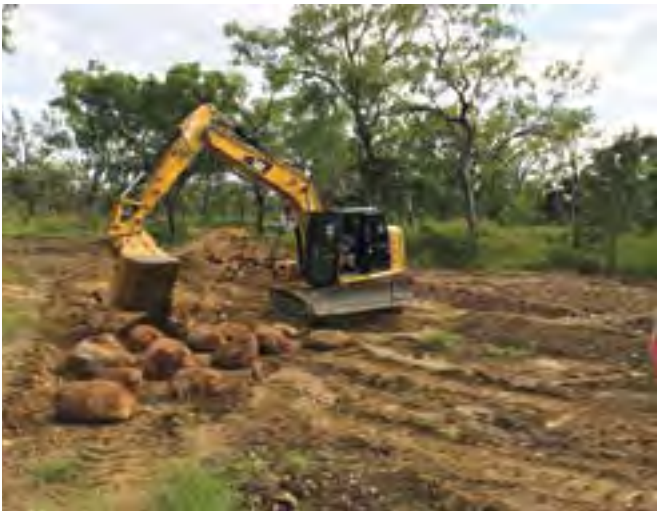
Backfilling between rocks

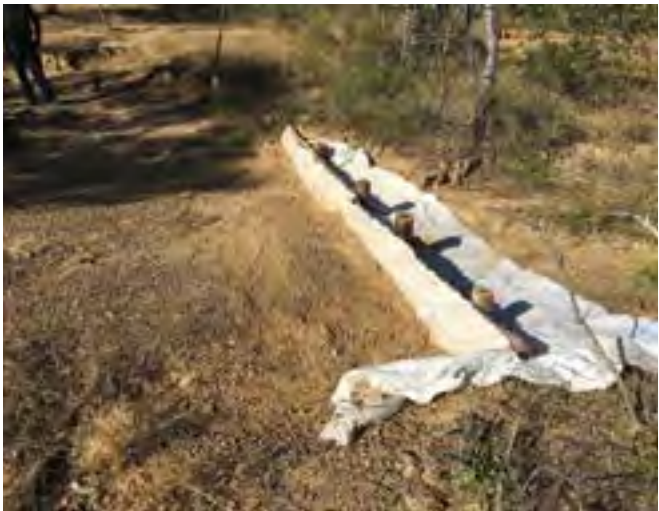
Geotextile fastened to structure

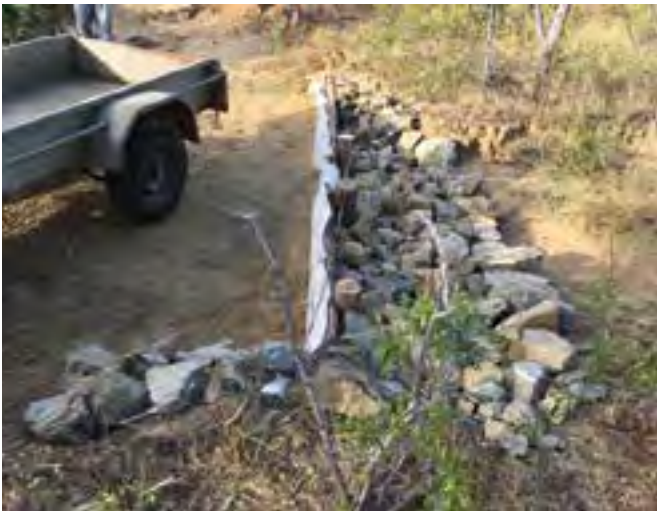
Rock apron

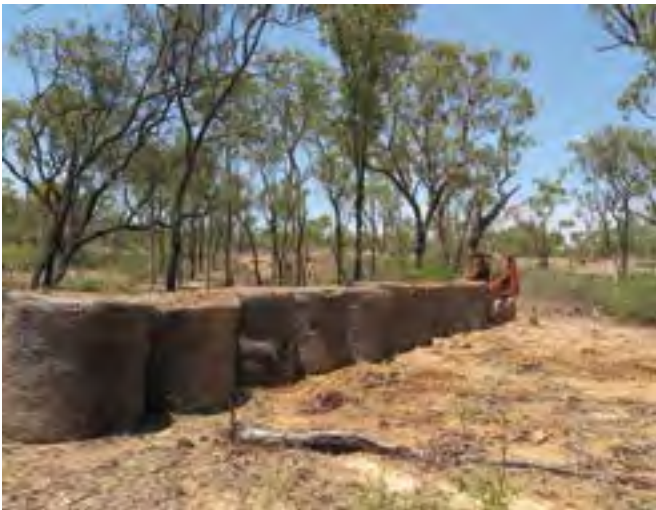
Placement of bales

The hay bale weir was installed as a temporary measure to slow the flow of run-off from the sub-catchment above the structure. Due to the scalding below the structure, and the loosening of the soil during construction on gullies 2.2 - 2.4, large quantities of soil were at risk of being dislodged. This temporary structure was used to slow and distribute the flow over a wider area to reduce the possibility of sheet erosion, and to allow for grasses to establish around the site.

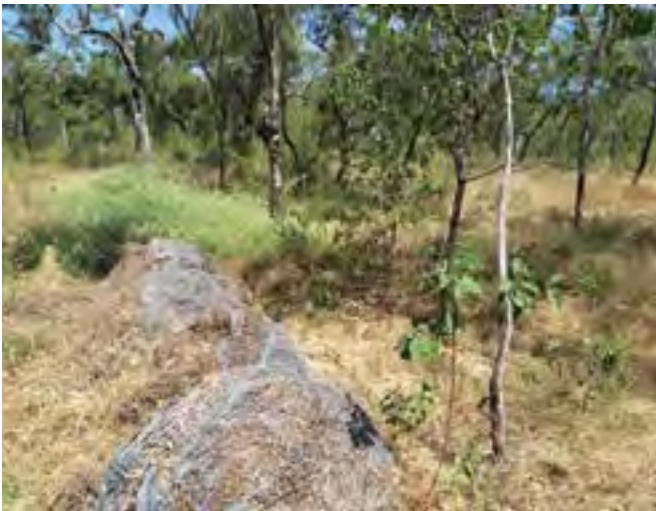
Hay bale structure after the 2017-18 wet season

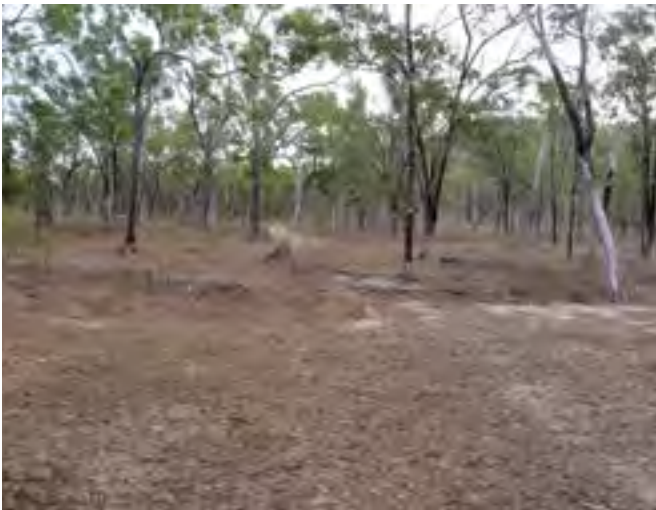
Road crossing before repair

The purpose for repairing the road crossing was to increase the efficiency of the heavy earthmoving machinery bringing materials to the gully areas being remediated. Over time the track had been constantly moving around the gully headcut into the low lying area above. This repair has completely halted the movement of the headcut and removed the erosion risk to the seasonally inundated landscape above.

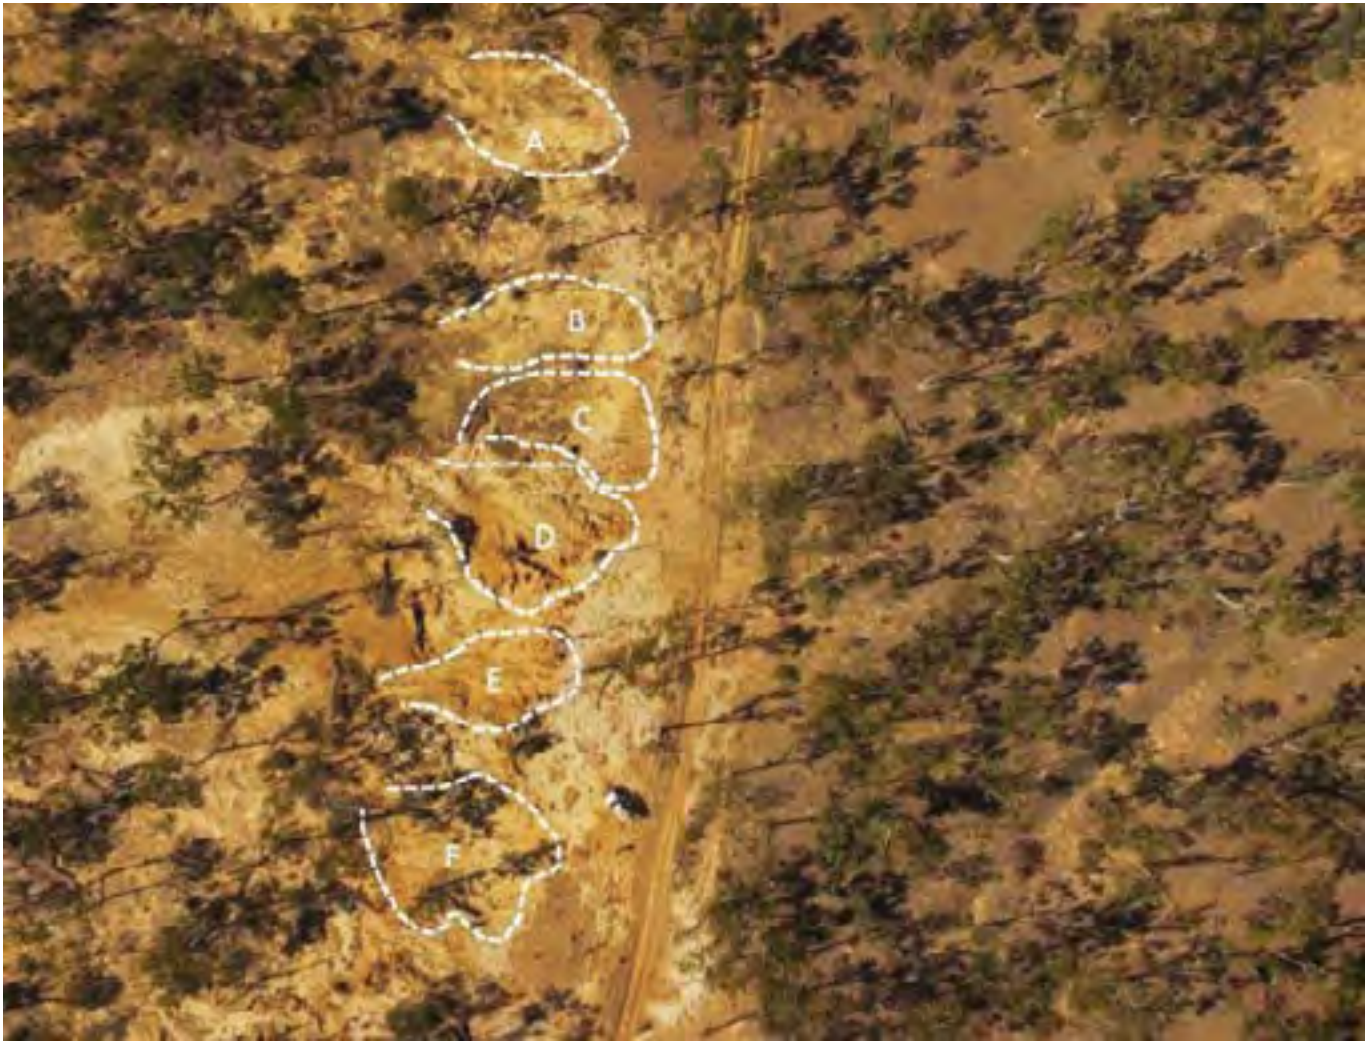
Gully Lobe	Approx. area (m²)	Treatment
A	650	Regrade, gypsum, compost and grass seed
B+C	1670	Regrade and capping
D	1070	Regrade, gypsum, dolichos mulch and seeding
E	680	Control
F	1050	Control

Upper catchment of gully 1.1 treatment layout

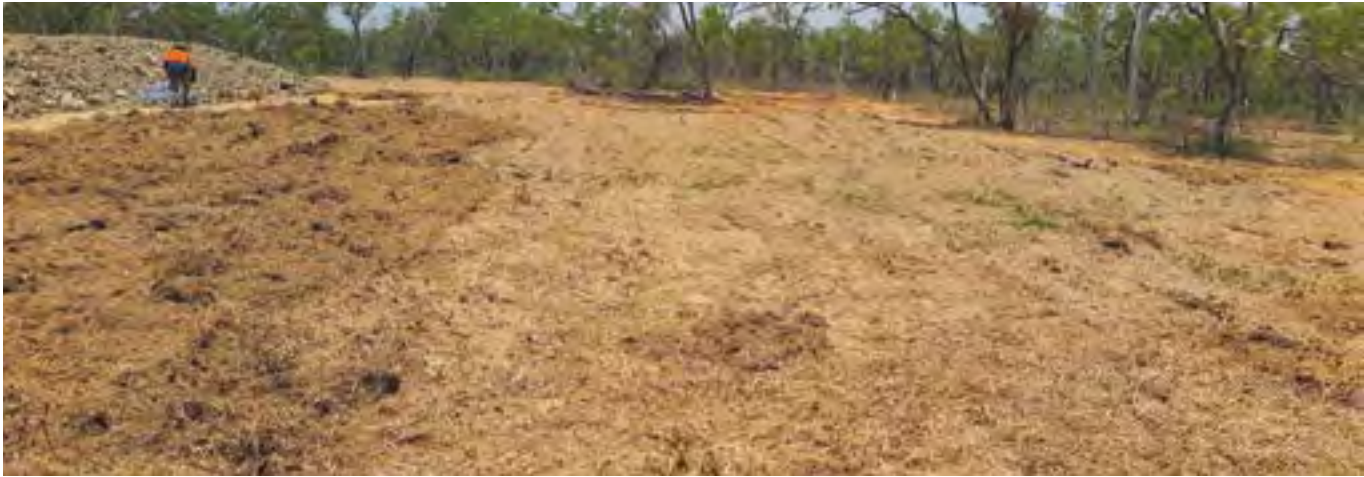
Mulch after rolling out 2016

Mulch was sourced from a Lakeland farm and consists of the trash from harvested Dolichos. Dolichos mulch is high in nitrogen and has proven to be a good ground cover, more so in the second year as it creates a large amount of heat when decomposing. The outcome of this trial is that the mulch layer has achieved near 80% vegetation cover in 2017-18.

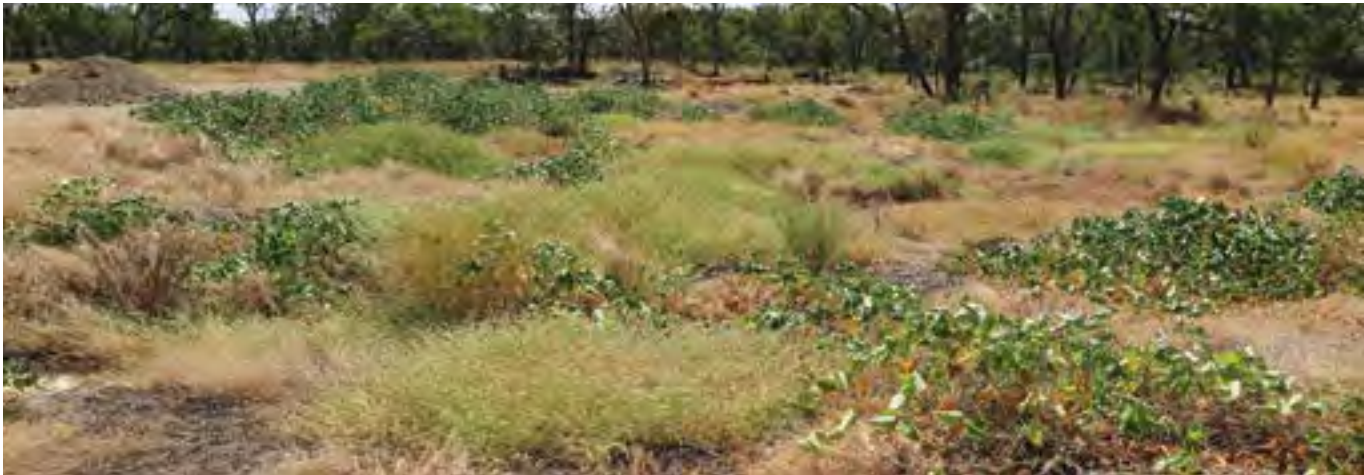
Mulch after 2017-18 wet season

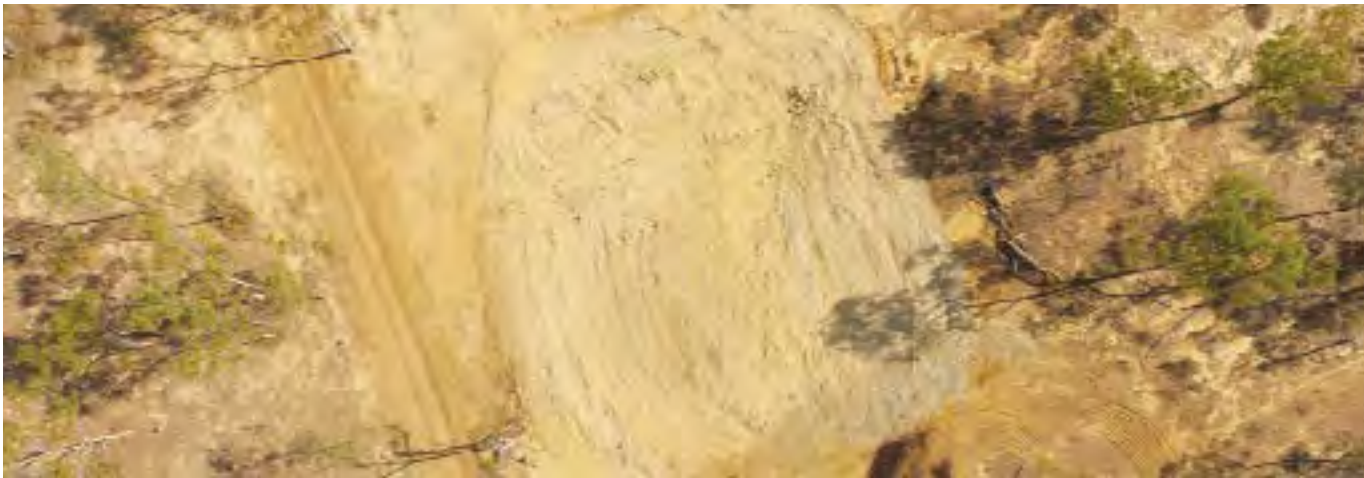
Rock capping post construction

Rock used to cover this trial site was locally sourced from the Crocodile Gap area, the rock has proven to be a reliable cover but is difficult to establish vegetation in and has achieved less than 5% cover in the 2017-18 wet season, this is however an increase in cover from the 2016-17 wet season.

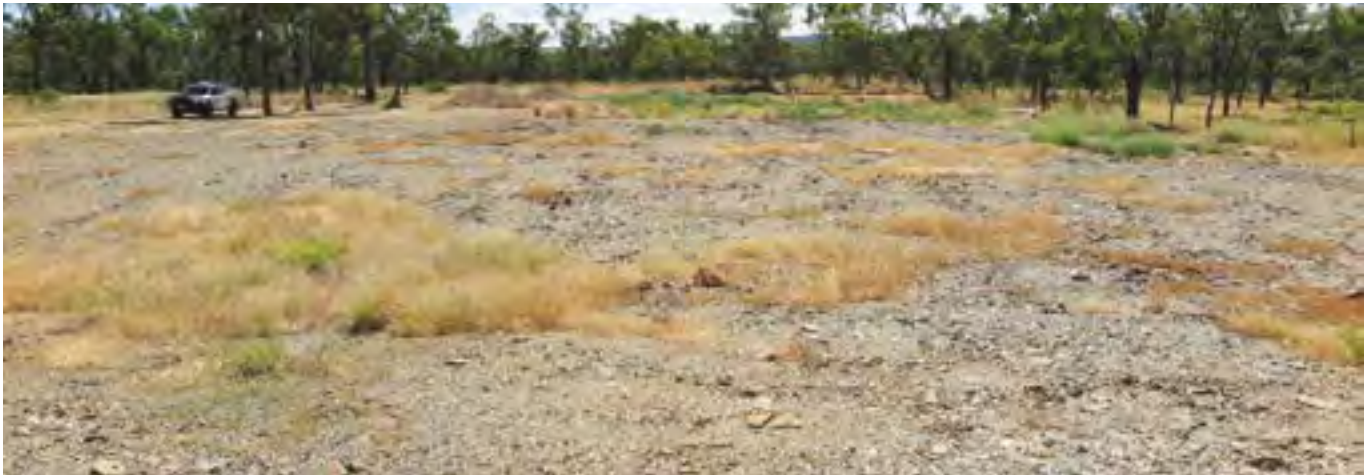
Rock Capping post 2017-2018 wet season

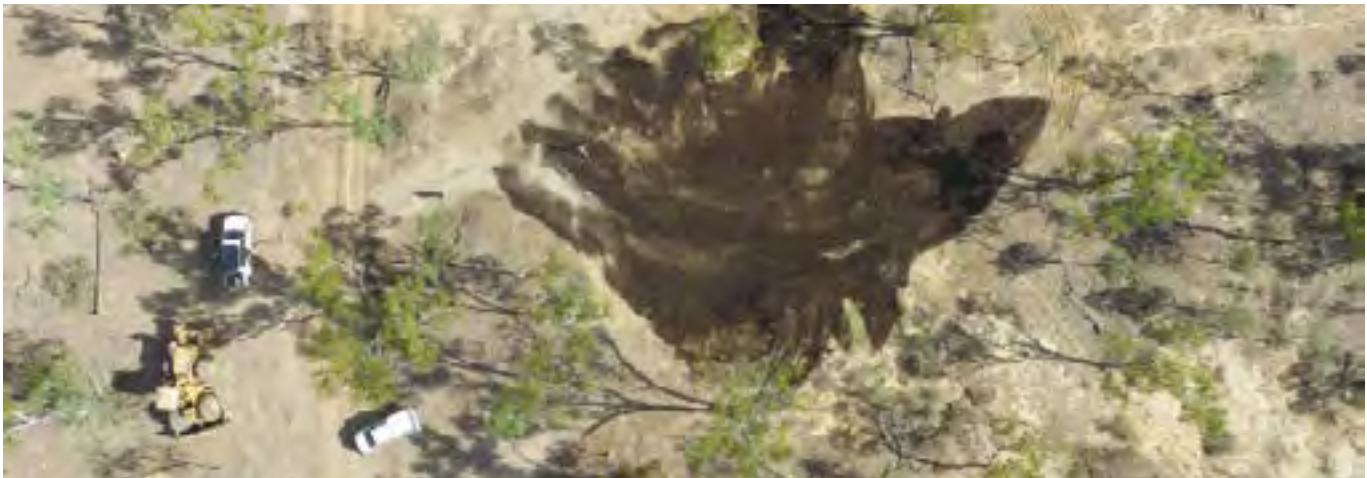
Compost after spreading with dozer 2016

Compost was sourced from a Lakeland compost producer and was spread using a rubber tyred dozer, the compost has proven to be a reliable way to establish grass cover on sodic

soils but a large quantity was lost in runoff in the 2016-17 wet season. The compost trial has achieved near 90% vegetation cover at the end of the 2017-2018 wet season.

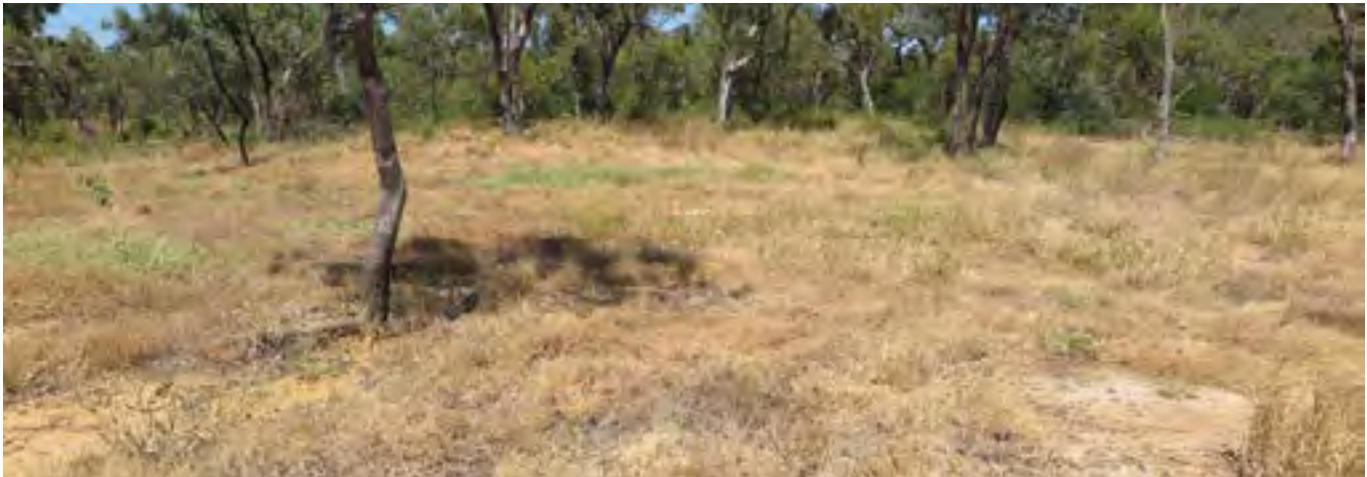
Compost layer post 2017-18 wet season

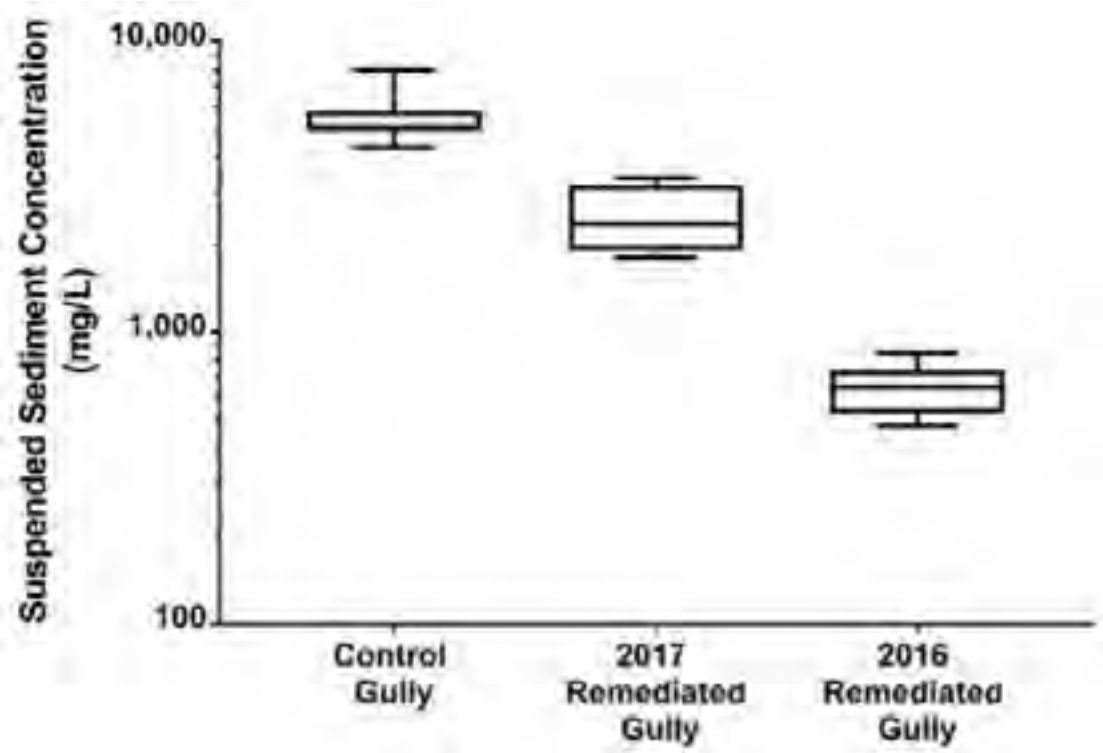
Box and whisker plots of suspended sediment concentration for the control and remediated gullies at Crocodile Station, QLD. The box and whisker plots present the minimum, 25th

percentile, median, 75th percentile, and maximum of each gully dataset from rain storm samples collected on January 24, 2018.

Over 100 samples were collected and are currently being processed. Initial water quality results indicate that the remediation works performed on the gullies have successfully reduced the amount of suspended sediment being transported by rain storm driven erosion. For example, the analysis of water samples collected during an isolated rain storm flow event (20-30 mm of rain in under 6 hours) in three of the gullies is shown below. The gullies remediated in 2017 and 2016 had 50% and 85% lower median suspended sediment concentrations, respectively, compared to the control gully.
