Draft Plan Currently under Consultation and Review

Normanby Catchment Water Quality Management Plan

Australian Rivers
Institute
Griffith University

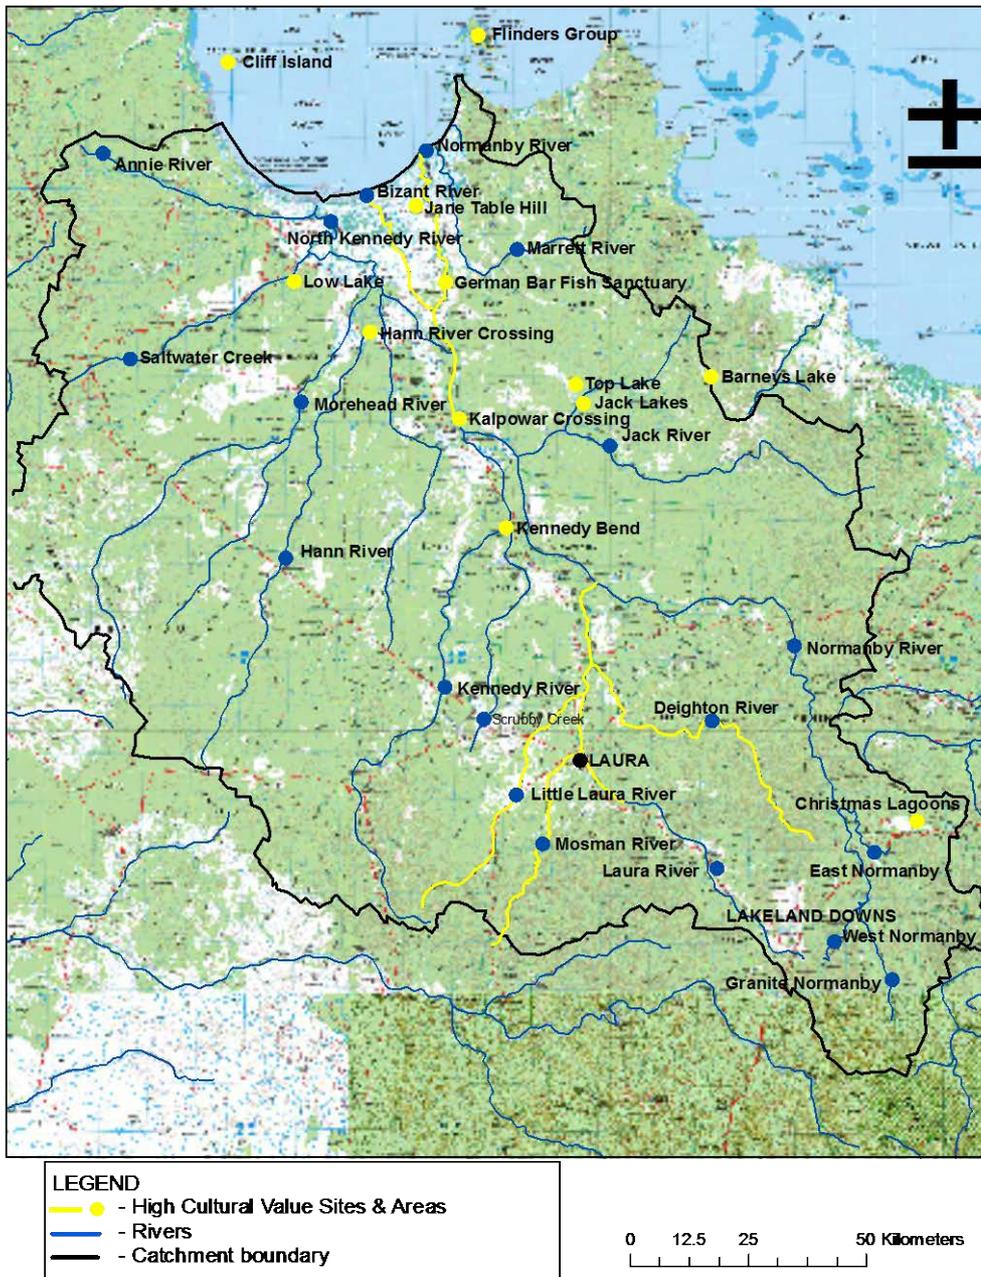
Figure 2: Identified High Cultural Value (HCV) Aquatic Ecosystems
(The cultural values and HCV sites remain under consultation with Traditional Owner groups. Not all sites have been mapped.)

High cultural value aquatic ecosystems are shown on Figure 2. Not all cultural values of the catchment have been documented and additional work is required to document cultural sites and the protocols for use of these areas.

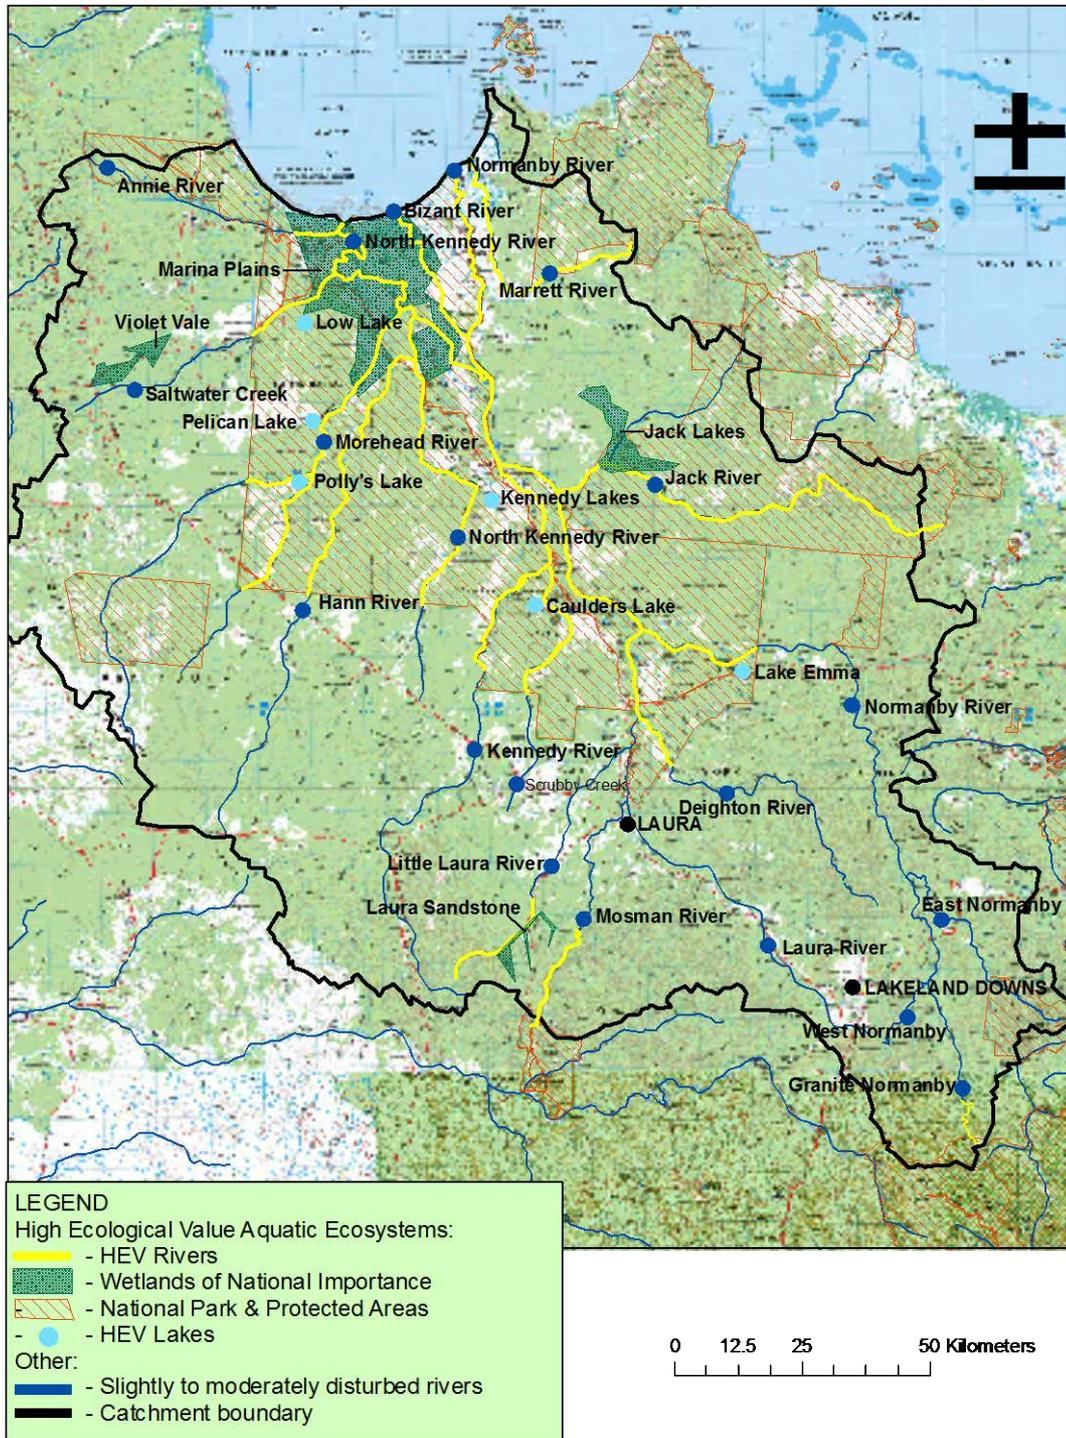
Figure 3: Mapped Areas of High Ecological Value (HEV) Aquatic Ecosystems and Existing Conservation Areas in the Normanby Catchment Area

Areas of known HEV aquatic ecosystems within the Normanby catchment are discussed in the following sections and are shown on Figure 3.

Jack Lakes, part of the Jack River NP, is an inland freshwater lake system covering 808 ha (Figure 3). The lakes flow south into the Jack River, which flows southeast into the Normanby River. The Lakes provide important dry season refuge for migratory waterbirds such as the magpie goose (*Anseranas semipalmata*), a much valued food source for the Traditional Owners of CYP. Flocks of over 1,000 geese have been observed at Jack Lakes, in addition to a high density of Wandering Whistling-Duck (*Dendrocygna arcuata*), Radjah Shelduck (*Tadorna radjah*) and Pacific Black Duck (*Anas superciliosa*). The wetlands also support large populations of freshwater turtles and fish (Stephan & Howley 2009).

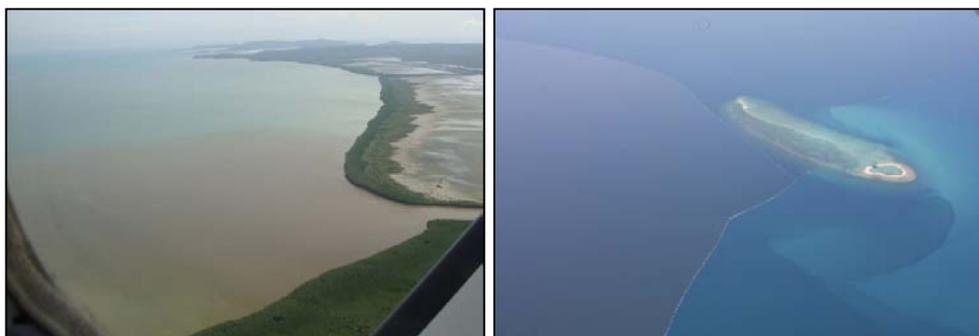
Figure 5: Flood Plumes at Normanby River mouth and Wharton Reef, PCB
(Photos: C. Howley (left), A. Hogbin (right) 13-2-2009)

The Flinders Group of Islands and their associated reefs are approximately 25 km northeast from the mouth of the Normanby River, while major reefs such as Corbett and Clark are over 30 km away. Despite these distances, major flood plumes from the Normanby and other PCB rivers regularly inundate the islands and reefs (Figure 5). This delivery of nutrients is likely to underpin the productivity of the reef ecosystem; however a significant increase in sediment or nutrient levels in annual flood plumes has the potential to impact on coral health.

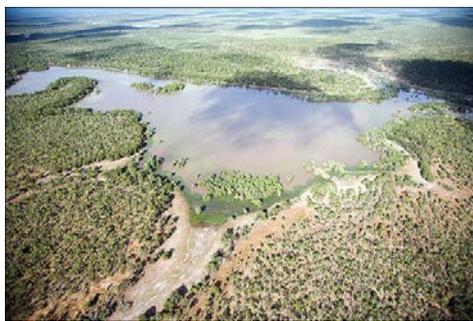
The "Top Lake" at Jack Lakes is a shallow, turbid lake (Figure 6). According to the indigenous land managers, the Top Lake, which is an important Story place, has been rapidly becoming more shallow and turbid in recent years (Michael Ross, pers. comm., July 2012). The source of accelerated sedimentation has not been documented; however, recent research showed that the Jack River was one of the few rivers within the Normanby basin for which the sediment load was dominated by surface soil erosion (Brooks, et. al 2013). Wetland condition assessments by CYMAG Environmental (2007-2009) found the Top Lake to be highly impacted by feral pigs and cattle, which can mobilise soil and accelerate sedimentation (Stephan and Howley 2009).

Figure 6: Jack Lakes “Top Lake” (Peter Pal Photography, 2007)

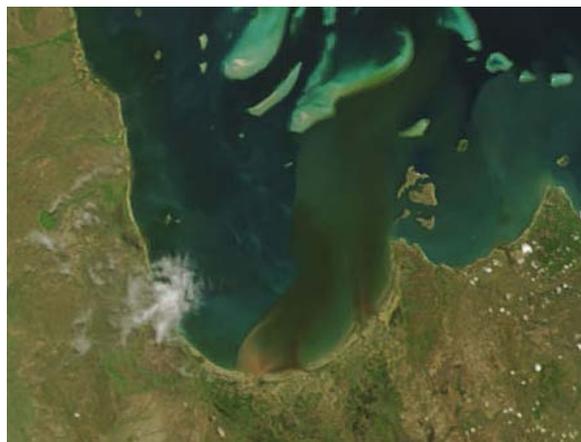
During flood events, plumes of sediment, nutrients and organic matter from the Normanby River, other rivers and distributaries (Bizant, Kennedy, Marrett Rivers) and the coastal plain are discharged into Princess Charlotte Bay and can extend to the Great Barrier Reef (Figure 7).

Figure 7: Normanby and Kennedy R. Flood Plumes, Feb 2007 (MODIS satellite image)

High concentrations of nutrients, particularly dissolved inorganic nitrogen, have been detected in flood plumes at PCB (Howley & Devlin, unpublished data). As with the concentrations within the river during floods, the primary sources of these nutrients in PCB and how much they have been influenced by land use is not known.

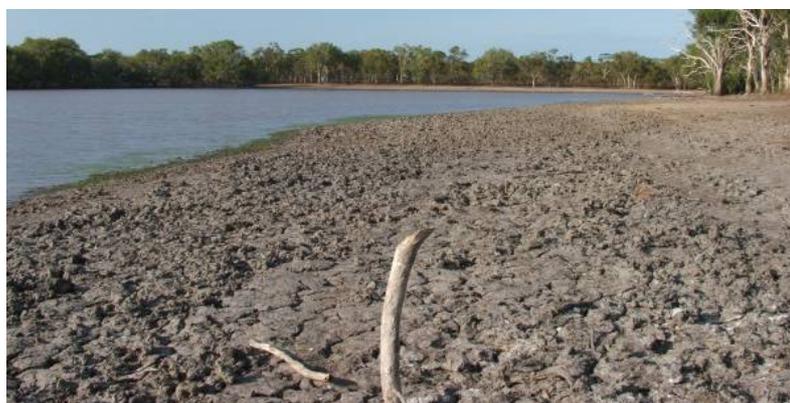
Figure 11: Cattle hooves degrade soil and edge vegetation at Jack Lakes

Deep cattle pads worn into steep river banks and adjacent areas cut into highly erodible sodic soils and can initiate alluvial gully erosion (“breakaways”). Accelerated water run-off from reduced grass cover also can promote the development of alluvial gullies on floodplain margins (Brooks et al. 2009; Shellberg 2011, Shellberg and Brooks, 2013). **The rate of gully erosion along river frontage areas has increased by at least ten times in some parts of the upper catchment since the introduction of cattle** (Brooks et al. 2013; Shellberg and Brooks, 2013).

The congregation of cattle in and around streams and wetlands in the catchment has been linked to increased turbidity, nutrients and bacteria and may lead to increased algal growth during the dry season (Howley 2010, Stephan and Howley 2009). Cattle are attracted to most permanent waters in the catchment, including large numbers of feral cattle that exist within National Park areas. Managing cattle to avoid further erosion and degradation of rivers and wetlands is crucial to maintaining and improving water quality in the Normanby catchment. Removing cattle from National Park areas is critical for protecting HEV waters.

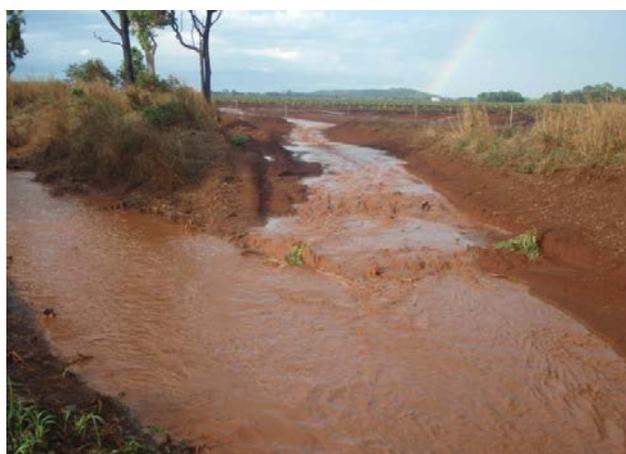
Figure 12: Sediment laden water run-off from a recently cleared banana farm (December 2011)

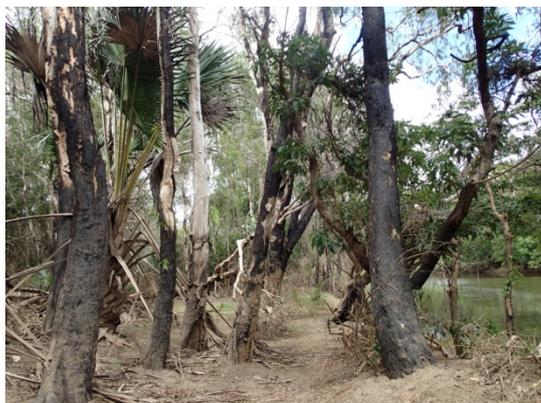
High intensity (late dry season) fires have been used to successfully control rubbervine (a highly invasive weed) in some riparian HEV areas (Stanton, 1995). However, intense fires can destroy sensitive vegetation types and still not kill large established rubbervine plants. Storm burns may be more effective at killing established rubbervine plants. Where high intensity fires are necessary in riparian areas, early dry season burns should be used to create firebreaks and keep hot fires contained along small (2-3 km) stretches of the river (Mick Blackman, pers.comm., July 2013). Areas with high gully erosion potential (sodic soils) should be avoided to reduce accelerated erosion at the beginning of the wet season. However, if perennial grass and riparian cover can be improved, it

Figure 14: Evidence of high intensity fire in riparian paperbark forest on the Kennedy River, Rinyirru National Park (Photo: C. Howley, April 2013)
