Case study

Gully remediation at Spring Creek

Working with land managers to reduce sediment loss

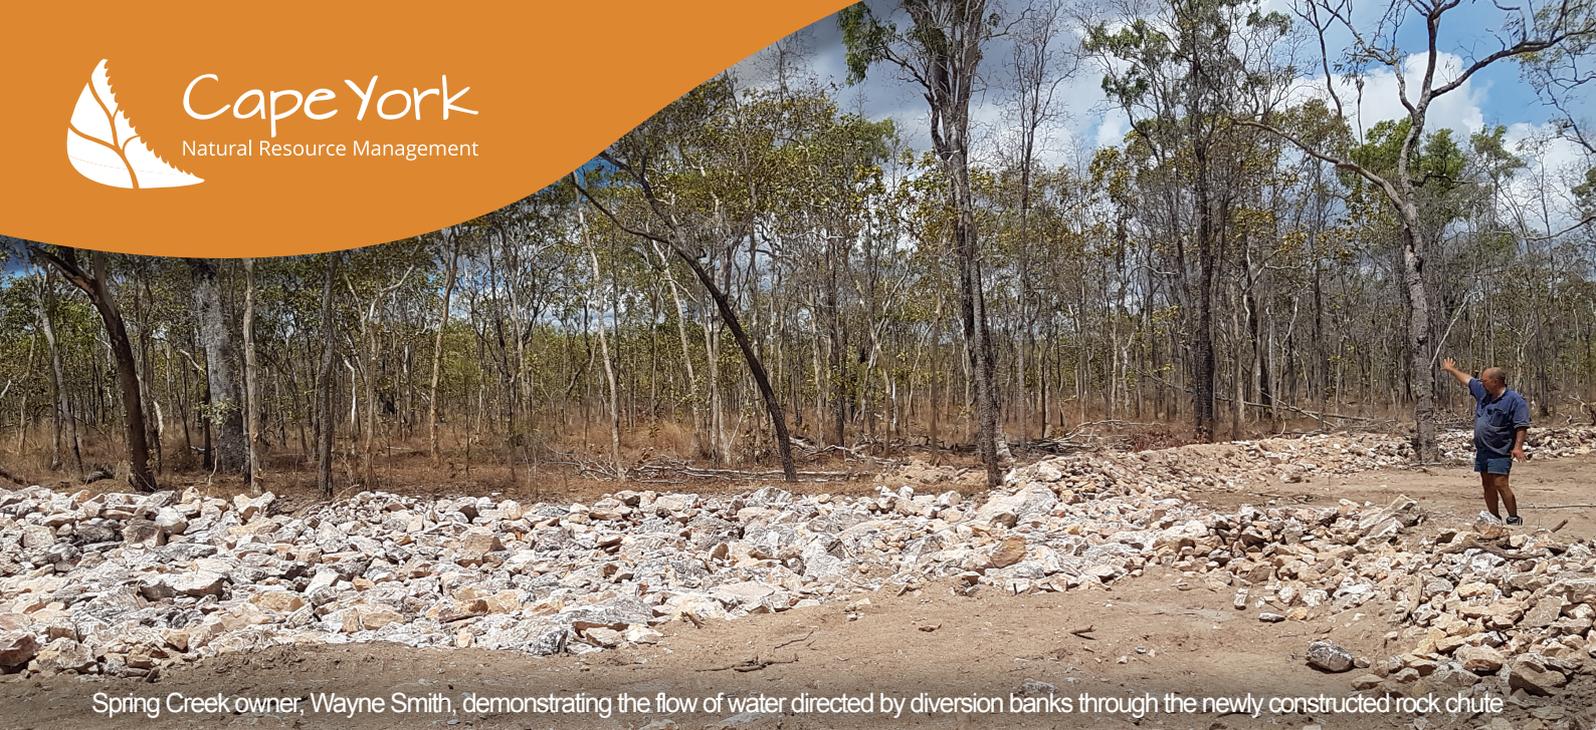
Spring Creek owner, Wayne Smith, demonstrating the flow of water directed by diversion banks through the newly constructed rock chute

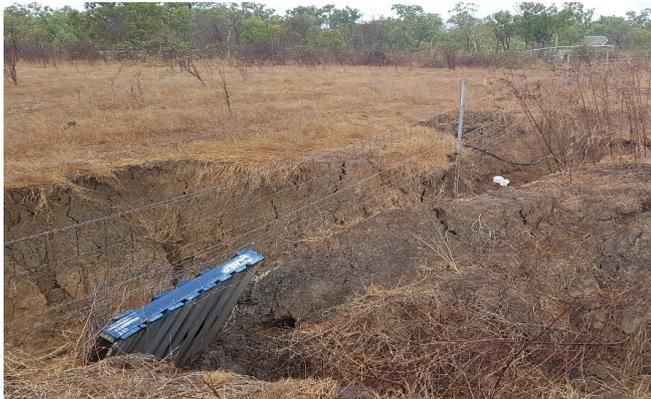
Fencing infrastructure undercut by gully erosion

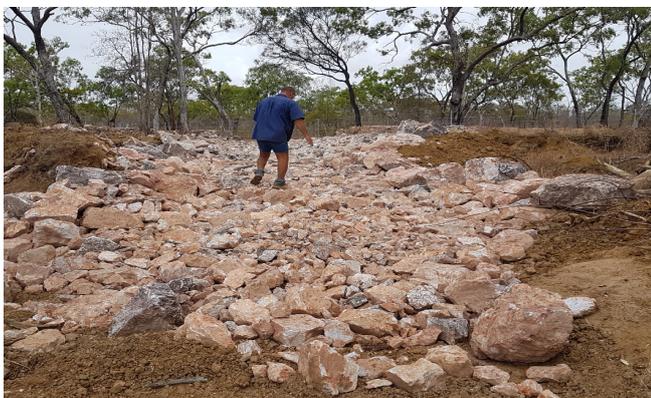
Wayne inspects a rock chute at a scalded area

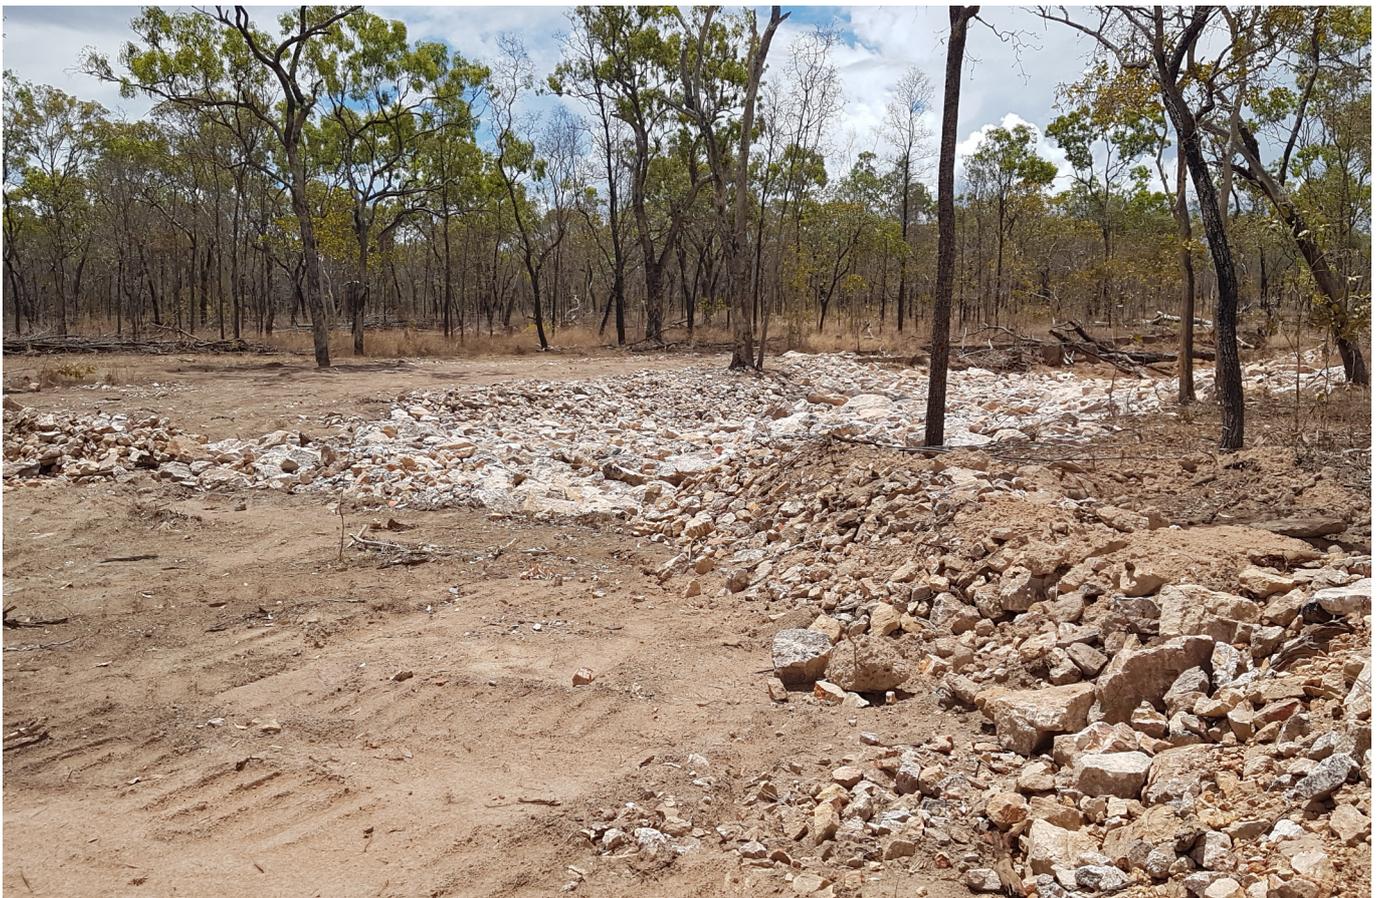
Rock chute installed at the gully head, with diversion banks to direct water towards the chute

- Cattle exclusion fences
- Rock chutes located at the gully head—rock chutes are ramps that stabilise the head of the gully and stop it from migrating during rainfall events
- Diversion banks to direct water towards the rock chute and prevent gully branching
- Porous check dams to slow water flow and trap sediment
- Shallow ripping of scalded areas, followed by mulching and seeding to encourage grass growth
