Case study

Gully remediation at Normanby Station

Working with land managers to reduce sediment loss

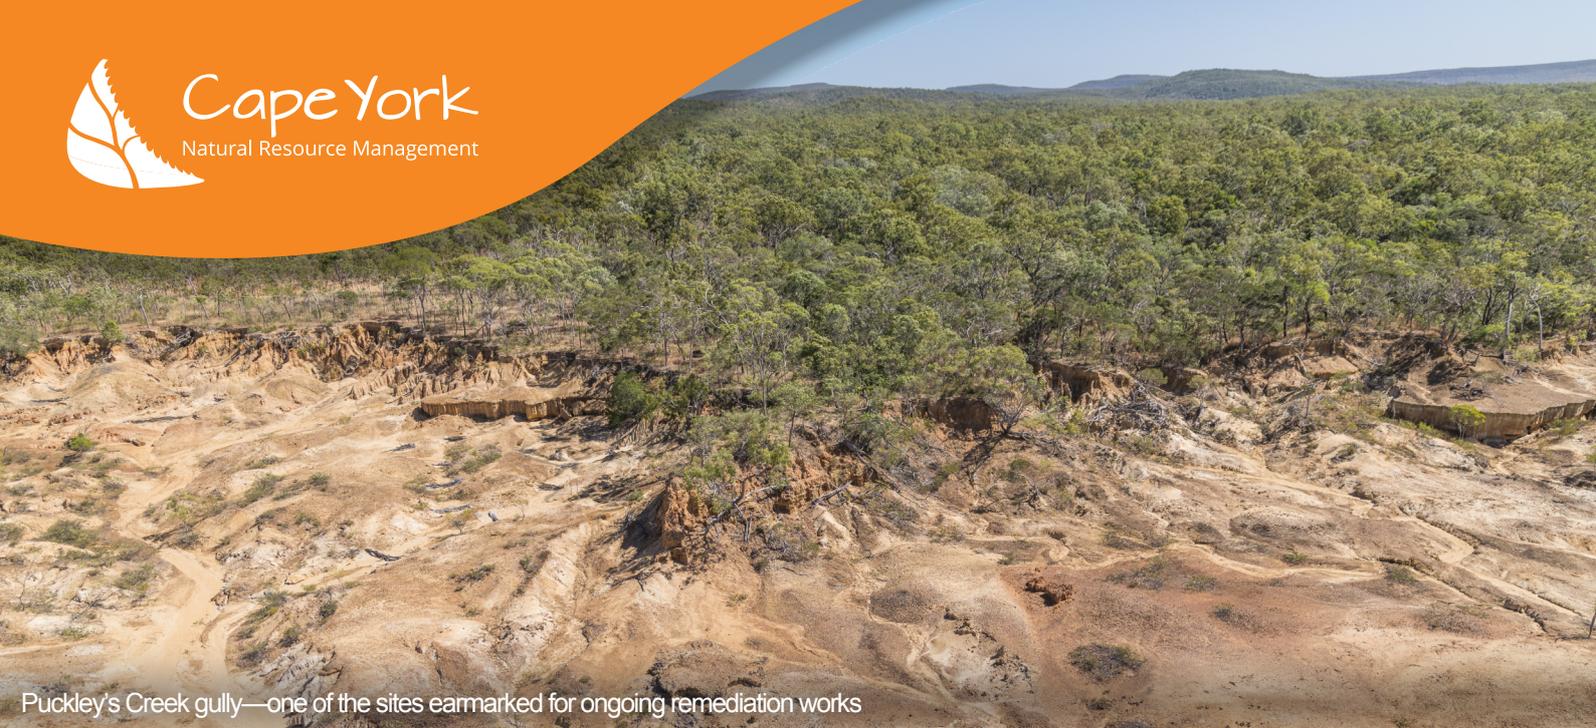
Puckley's Creek gully—one of the sites earmarked for ongoing remediation works

Reshaping: several gullies have been completely ‘flattened’ by battering down walls and capping with less erosion-prone soil. Reshaping work is planned for the banks of large gullies at Clayhole Creek and Puckley’s Creek.

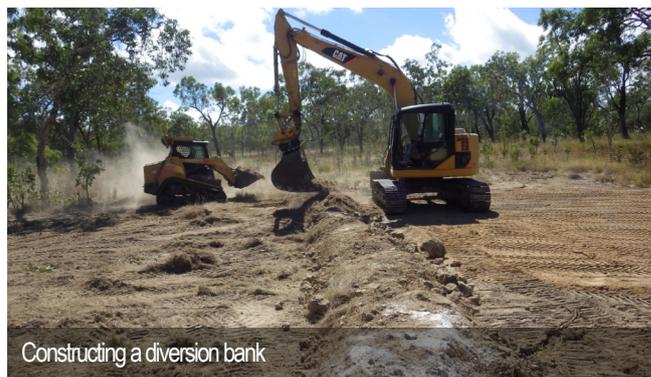
Constructing a diversion bank

Rangers have built diversion banks surrounding the gully heads to divert water away from the gully to a flat, well-vegetated spot. In other cases, banks are used to direct water towards the gully head, where a rock chute or other grade control structure guides water safely through the gully.

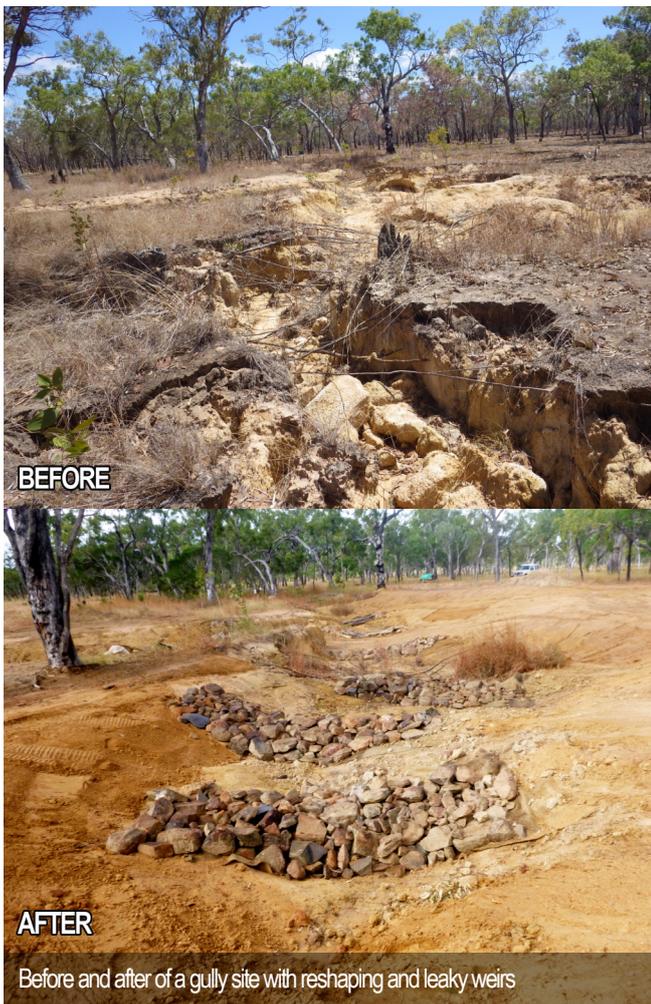
Leaky weirs: slow down the flow of water and trap sediment on gully floors. At Normanby, leaky weirs have been built using a variety of materials—rocks, timber, hay bales, steel pickets and jute matting. They need to be sturdy enough to survive the wet season and wide enough to prevent gully outflanking around the structure.

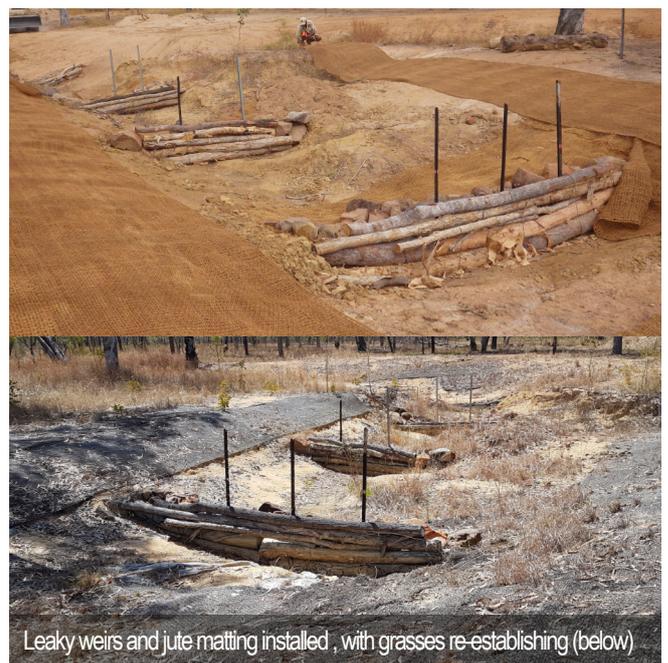
Drone photograph of leaky weirs installed at Puckley's Creek gully using hay bales and timber
